# **"Corrosion of Metal Matrix Composites"**

**Final Report  
Grant # F49620-93-1-0500  
Air Force Office of Scientific Research  
Bolling AFB, DC 20332-8080**

**November 1997**

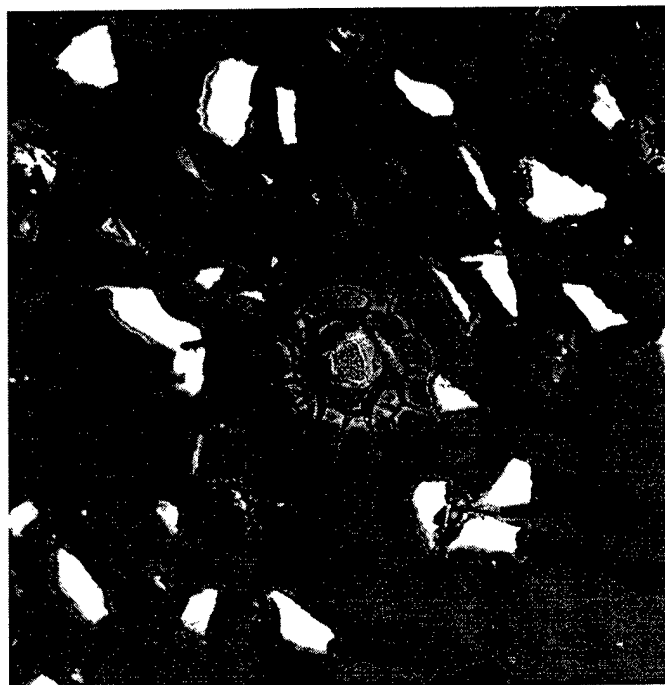
Fig. 12 Titanium-rich intermetallic particle showing rapid pit initiation after 30 minutes immersion while nearby  $\text{Al}_2\text{O}_3$  particles remain unattacked.

The second, however, was the more common, more severe, and was associated with a specific site which showed early and rapid pit nucleation while nearby particles were totally unaffected, Fig. 12. These particles were investigated by EDS analysis and it was found that the particles and pit interiors appeared to exhibit a Ti content which was unusually high given the initial Ti content of 0.12%. Subsequently, X-ray mapping of polished but uncorroded samples revealed the presence of a large number of Ti/Zr rich particles which were the same size and shape as the  $\text{Al}_2\text{O}_3$  particulates and which had previously gone unnoticed. These particles were extremely active pit initiators and the remnants of these particles could be identified in the bottom of almost all the major pits after short immersion times. After longer immersion times, the particles had dissolved completely but the Ti from them remained detectable in the general region of the pit indicating dissolution and re-precipitation as part of an adherent corrosion product.

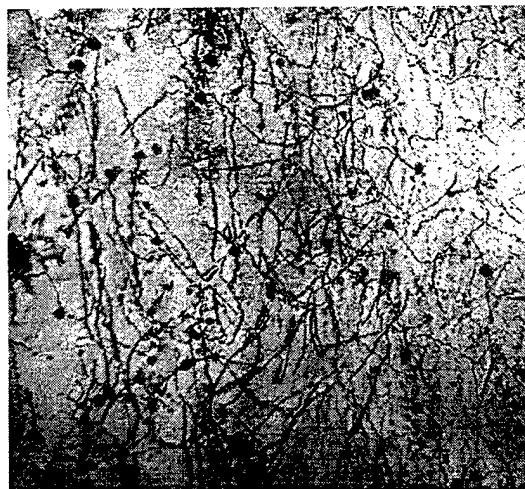
Fig. 13. Microstructure of Al6061-T6 showing precipitation of  $\text{Mg}_2\text{Si}$  on the dislocation substructure.

TEM was then used to investigate the types of precipitate present in the materials. In addition to the common  $\text{Mg}_2\text{Si}$  precipitates, Fig. 13, and a variety of Al-Fe-Mn bearing intermetallics, attention was focused upon the large,  $\sim 20\mu\text{m}$  in diameter, Ti-rich particles discussed above. These were found to be typically polycrystalline and to contain very high concentrations of Ti and Zr in addition to appreciable amounts of Si and Al. Figs. 14(a)&(b) show a typical particle at low and higher magnifications respectively. These show the particles to be composed of a small grain size core while the external surface of the particle has undergone reaction with the molten aluminum to form relatively larger, blocky grains of a titanium/zirconium aluminide phase. Fig. 14(c) shows the EDS spectrum associated with the blocky grains visible at the edge of the particle in Fig. 14(b). The occurrence and effects of these particles are considered further in the discussion section below.

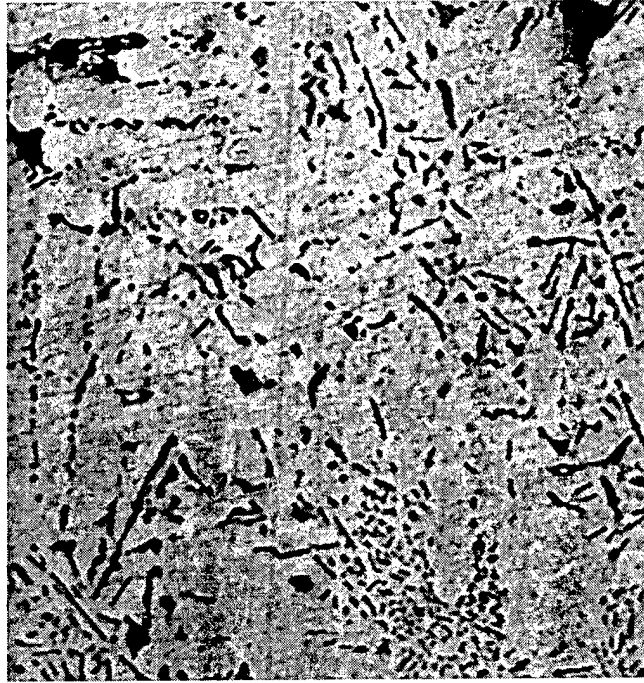
Fig. 18(a). Optical microstructure of unreinforced Al-Si alloy showing silicon eutectic.

Fig. 18(b). SEM micrograph showing interdendritic shrinkage porosity.

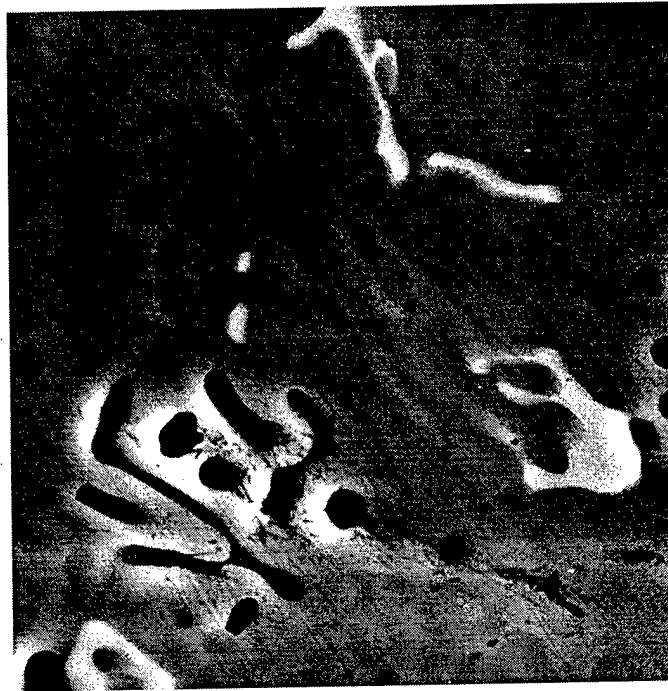
Fig. 19. 0%SiC<sub>p</sub>/Al-Si showing selective removal of one type of intermetallic particle during 12 day immersion test.
